Storm Damage Report

El Nacional Spanish Newspaper
304 SW 25th Street
Oklahoma City, OK 73109

FIELD REPORT FOR INITIAL STORM DAMAGE INVESTIGATION

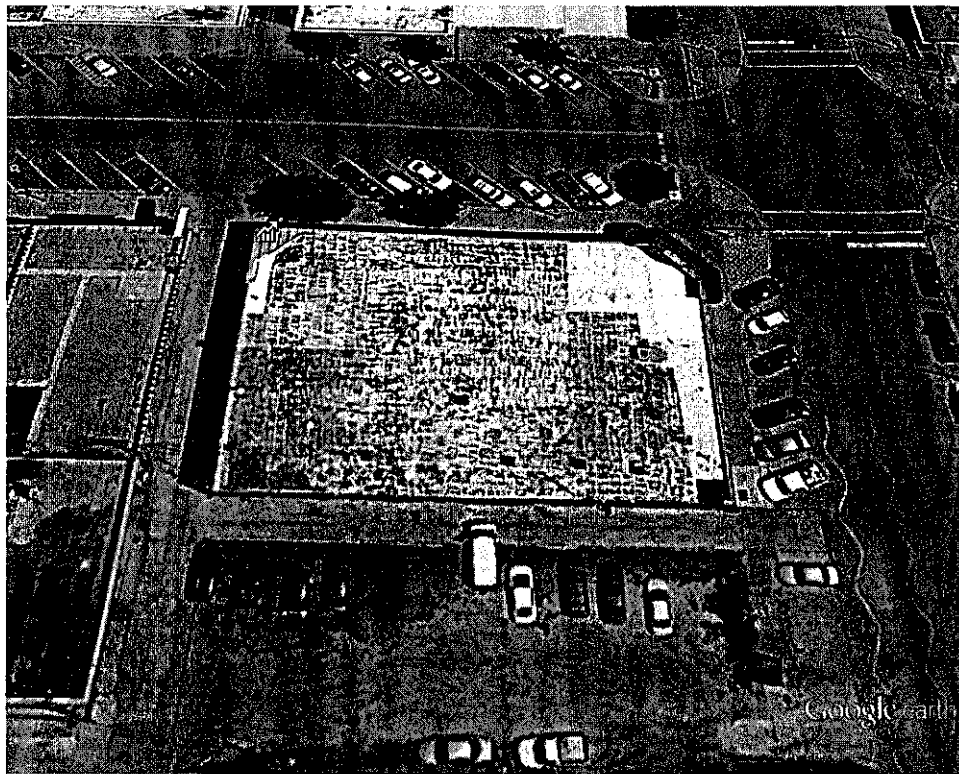
Google Earth imagery date 5/21/2013, before storm

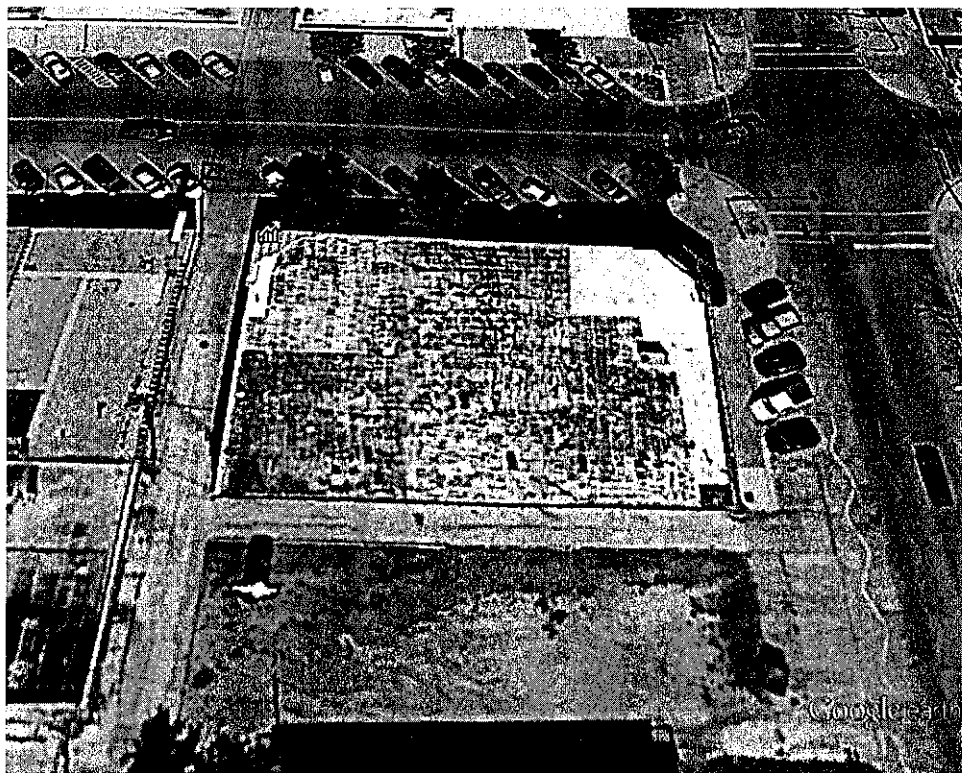
Google Earth imagery date October 5, 2013, after storm

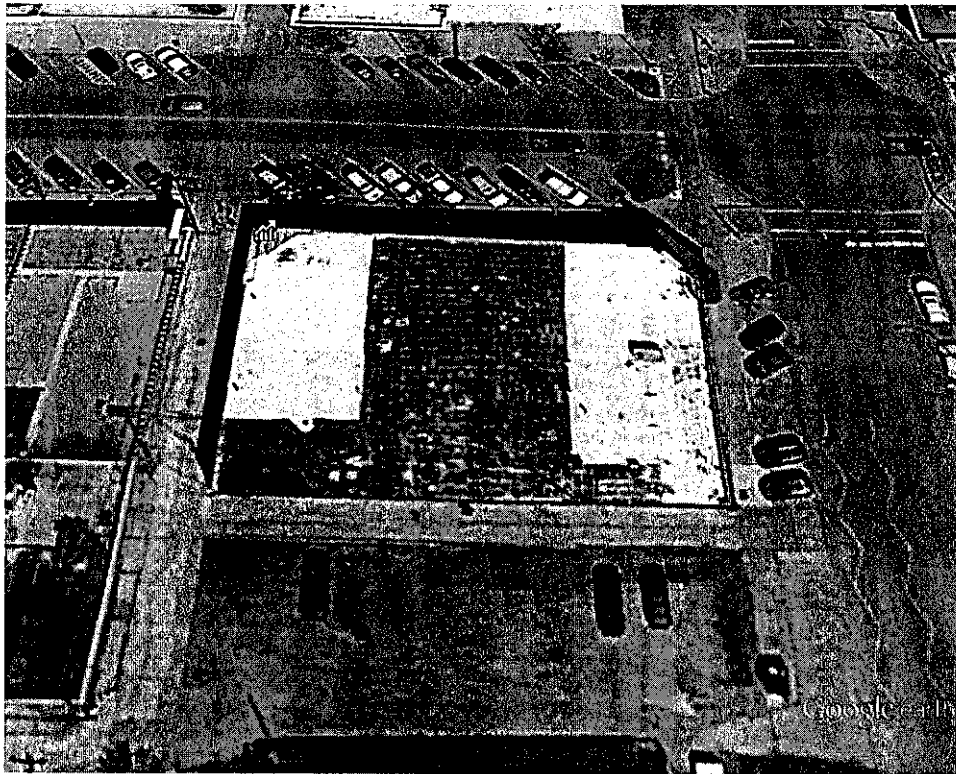
Google Earth imagery date March 25, 2015.

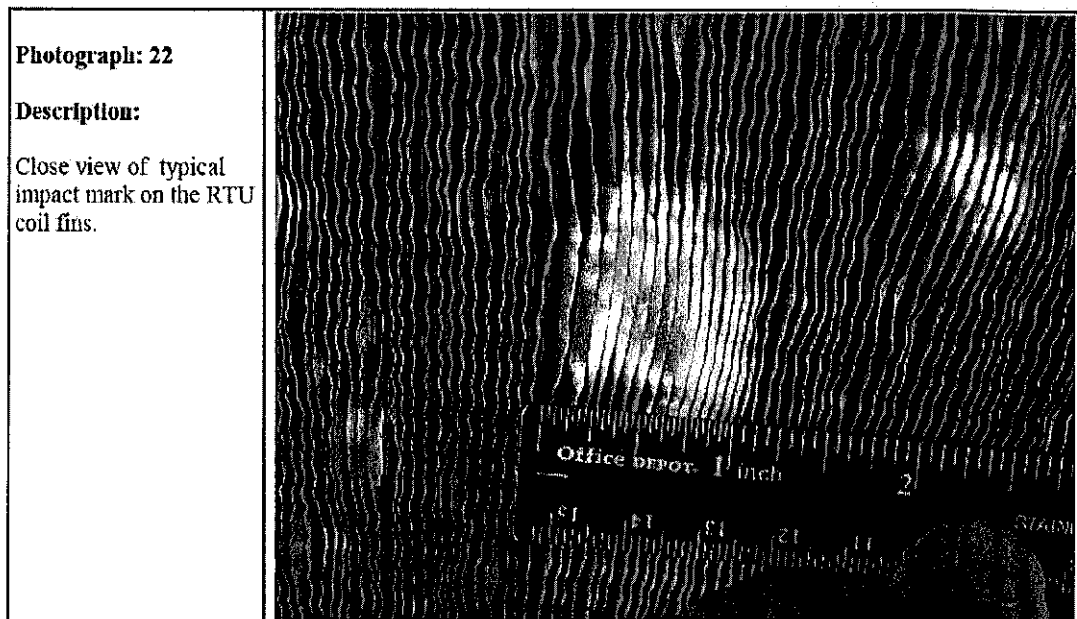
Source: Vertex report.

There are scattered dents in the aluminum fins of condensing coils on several air conditioning (HVAC) condenser units, and on the condenser fins of the RTU. The largest dents measured no more than 1 inch wide (Photographs 22), indicating the possibility of hail impacts of approximately 1-1/4 inch in size. There are small (less than 1 inch) dents on the tops of light gauge aluminum vent stacks (Photo 25). There are hail spatter marks on the tops of air conditioner condensers, measuring approximately 1/4 inch in size. There are hail spatter marks on the side of an electrical breaker box at the RTU, measuring approximately 1/4 inch in size (Photograph 23).

We observed many impact marks on the fins greater than 1" in size. Also, see K Construction photos of A/C units. Vertex failed to supply photos that accurately represent the size of the hail. For example photo 22 in their report shows only a horizontal measurement of the impact damage as 1-1/16" in size. When the same impact is measured vertically the impact mark is in excess of 1.75 inches indicating probable 2" plus size hail. Note: This is before the hail events of 2014 and 2015.

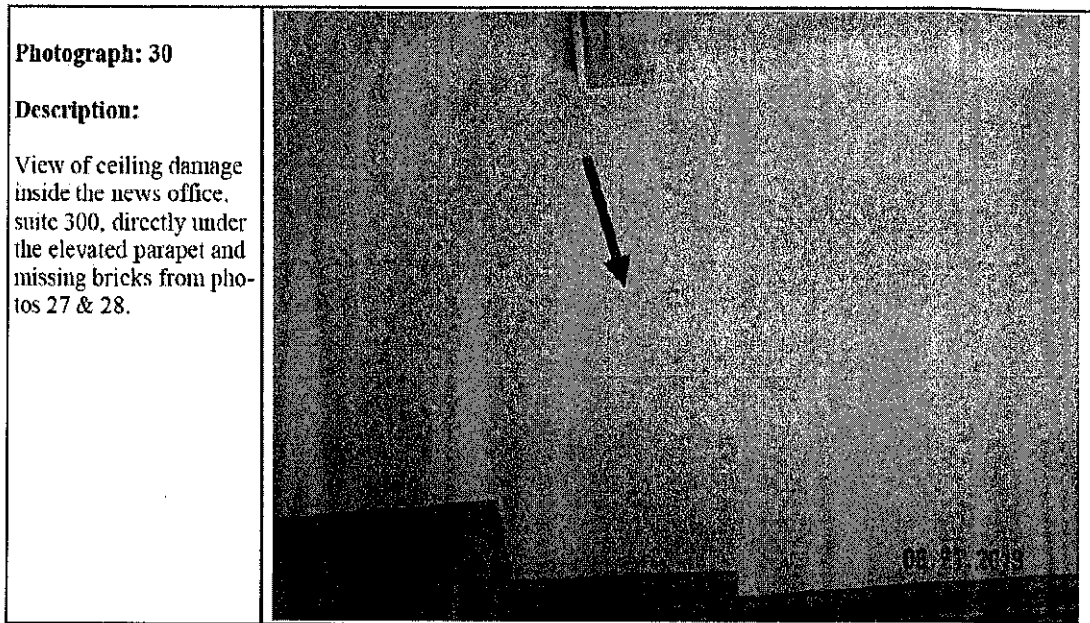
- 3.13 *The missing brick on the south end of the elevated brick parapet at the northeast corner of the building likely allows rain water to penetrate into the building and is possibly the source of the observed ceiling damage in the front northeast part of the news office.*

Vertex doesn't definitively opine the opening is the source of the ceiling damage in their Photograph 30.

Photograph 30 shows narrow cracks in the sealing near this area but no signs of actual water damage or stains are visible in the photo.
